**Subject: Preliminary Indoor Air Quality Assessment Report
Sky Valley Education Center – East Pod
EHSI Project 10693-01**

Sky Valley Education Center Preliminary Indoor Air Quality Assessment East Pod

**PRELIMINARY INDOOR AIR QUALITY ASSESSMENT
SKY VALLEY EDUCATION CENTER – EAST POD
MONROE, WASHINGTON**

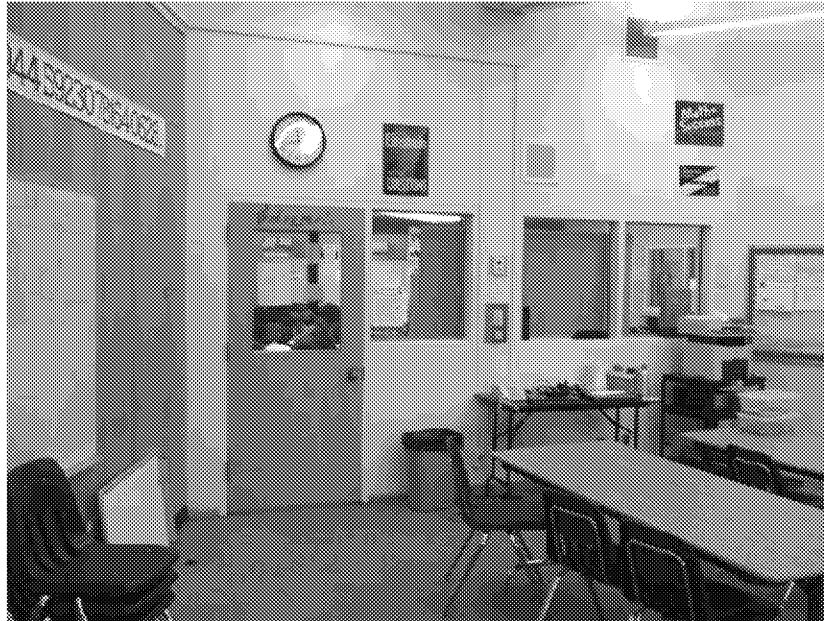
PHOTO #1: Classroom 11—view towards interior door. The East Pod Central common area is beyond the interior window.

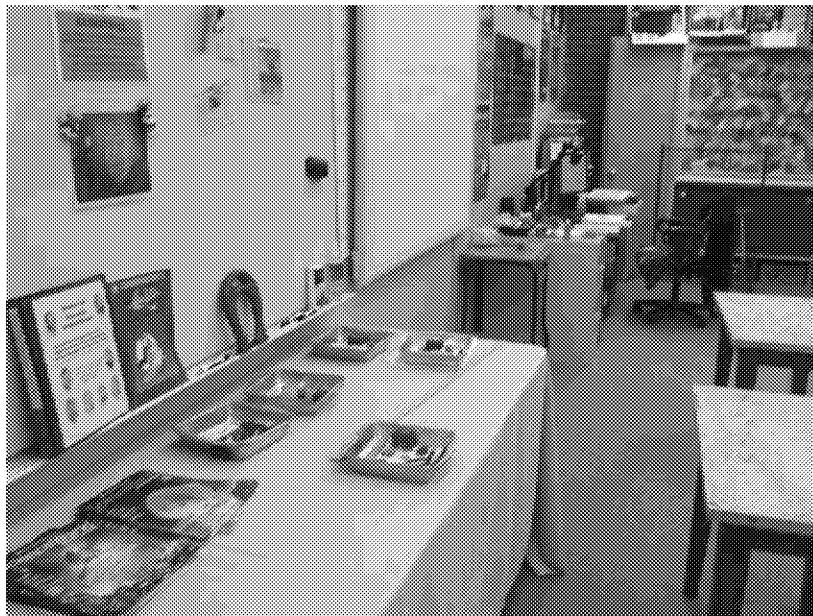
PHOTO #2: Classroom 9—Science Classroom

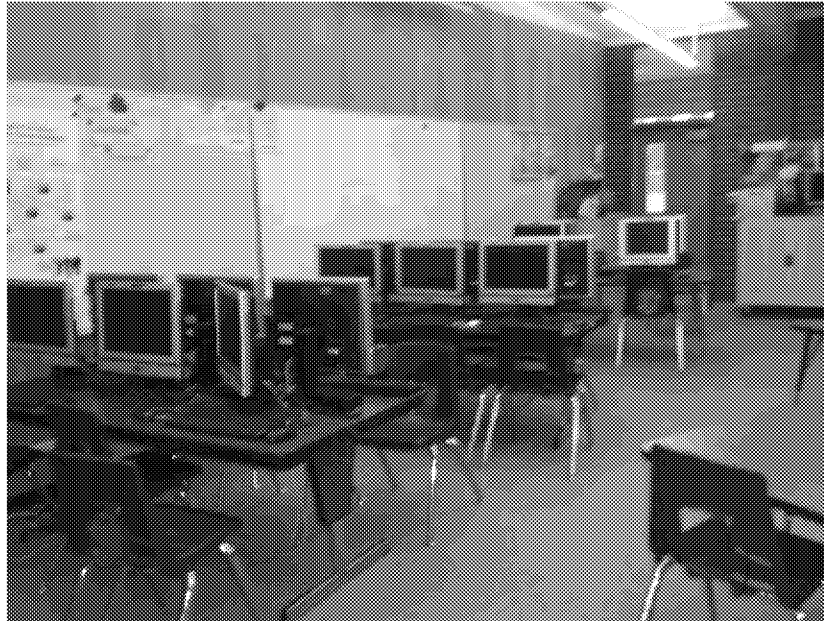
PHOTO #3: Classroom 10— Computer Lab. The exterior door is visible near the top right of the photo.

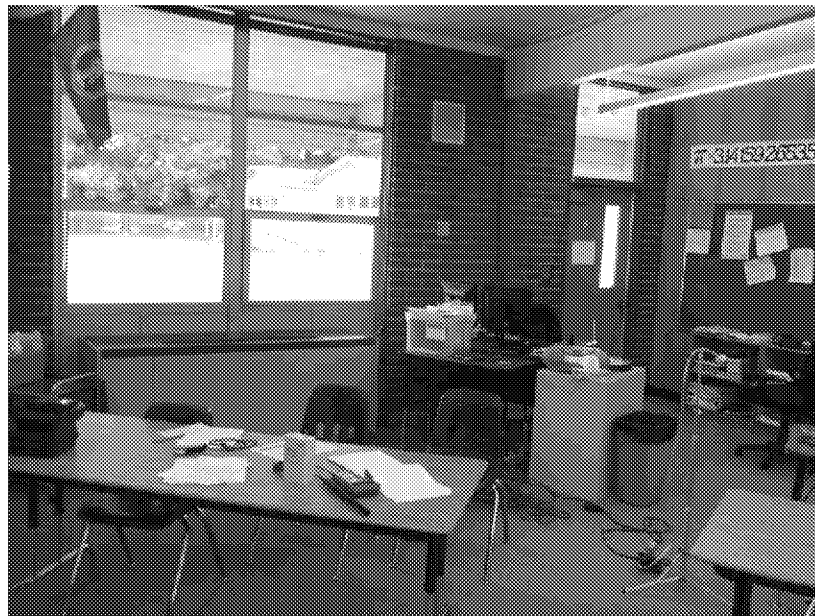
Each classroom has a unit ventilator, located along an exterior wall (Photo 4), which conditions air and provides outdoor ventilation air. The unit ventilators were manufactured by American Air Filter (AAF)/McQuay, Inc., a division of Daikin, and were reported to be approximately five years old at the time of the assessment. The unit ventilators have only a few fan speeds which must be set while the unit ventilator front panels are removed. Filters, with a MERV value of 8 or less, are located within the unit ventilators and reportedly changed out quarterly (Photo 5). Air intakes for the unit ventilators are located near ground level on exterior walls (Photo 6). Several of the unit ventilators observed had dampers on the exterior air inlet and were protected against skate board damage by additional caging around the grilles (Photo 7). The dampers for Classrooms 9 and 10 appeared to be more than 50% closed. The exterior air inlet for the unit ventilator in Classroom 11 did not appear to have dampers. The outdoor air inlets for the three classrooms of interest were on the side of the building opposite the school’s parking lot.

PHOTO #4: Classroom 11—The unit ventilator is positioned below the exterior window. The door to the exterior is visible towards the right side of the photo. Air sampling is taking place with the sampling cassette on a tripod towards the right of the photo.

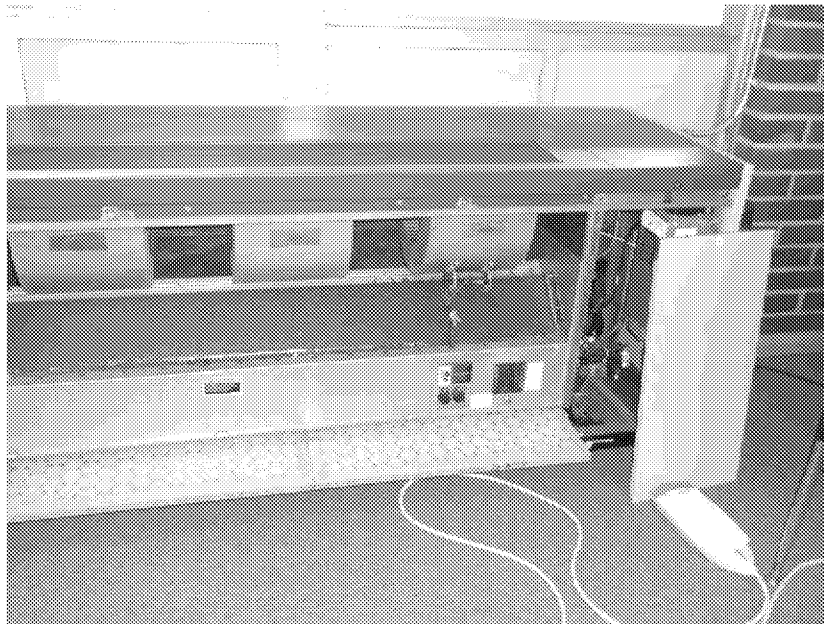
PHOTO #5: An open unit ventilator in Classroom 11. The filter are partially pulled out and appear to be clean and dry.

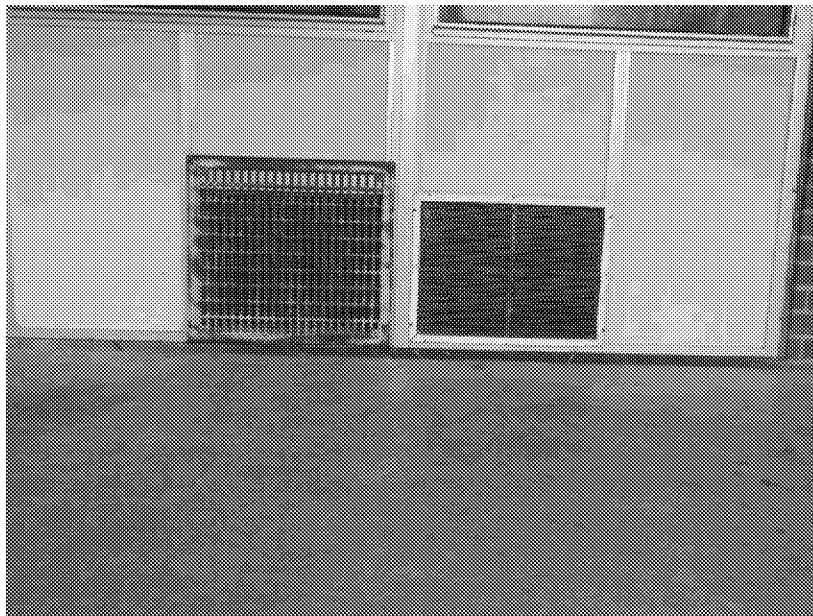
PHOTO #6: The exterior air intakes immediately outside from the unit ventilator in Classroom 11. The vents are protected against damage from skateboards and other activities by grilles. The grilles have iron corrosion. No dampers appear to be present at this air intake.

EHSI recommends increasing the amount of ventilation provided to classrooms by adjusting intake vent dampers and fan speeds, and/or utilizing the existing but not operational exhaust-only mechanical system in the East Pod. In addition, EHSI recommends that carpet directly inside exterior doors be removed and replaced by non-porous flooring such as tile or vinyl.

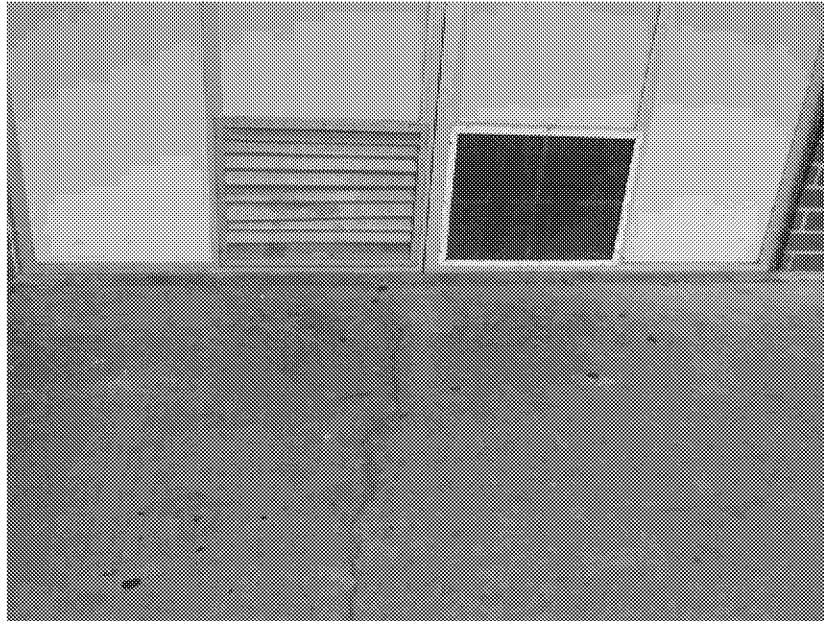
PHOTO #7: The air intake for Classroom 9 or 10. dampers are present in this air intake and appeared to be mostly, but not entirely, closed at the time of the assessment.

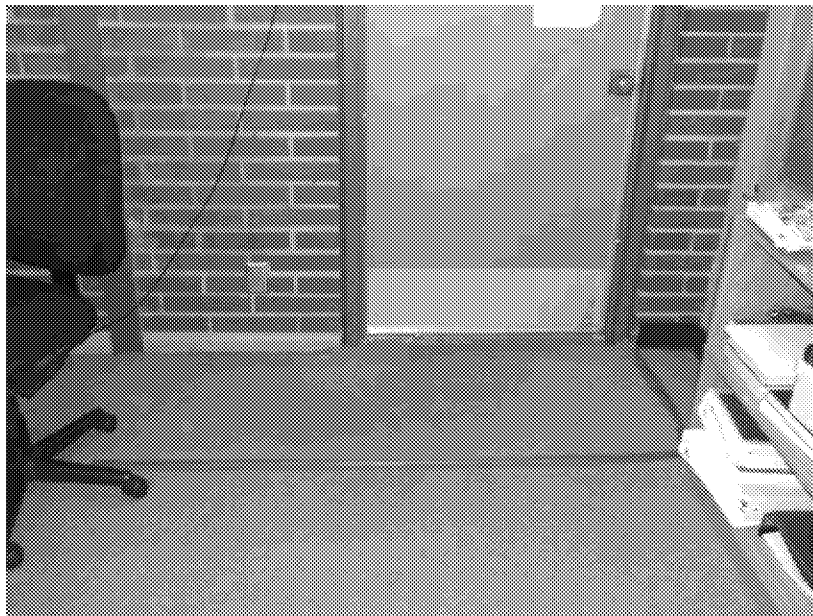
The carpet by the exterior door was being held in place by duct tape (Photos 8 and 9). The carpet mastic was well-cured with most on the concrete slab and some on the carpet backing (Photo 10). The carpet by the exterior door, approximately 1 x 4-feet in area, has a small area of discoloration with a “crusty” texture (several square inches) on the lower side (Photo 11) where it was closest to the exterior door. No suspect visible mold growth was associated with this area of discoloration but microbial growth may be present if/when this area of the carpet remains wet for a period of time.

PHOTO #8: Carpet by the exterior door in Classroom 11. A portion of the carpet had been cut out at some point in the past and is now held in place by duct tape.

- The carpets in close proximity to the exterior doors (approximately 2 x 3-feet) should be removed and replaced with a non-porous surface that will not be impacted by repeated wetting and drying. The use of a mat atop the carpet would protect the carpet but if used the mats should be regularly cleaned and turned so that all sides of the mat, as well as the carpet beneath, have an opportunity to dry.
- Consider installing a carbon monoxide sensor in the central common area of the East Pod to continuously monitor for carbon monoxide.

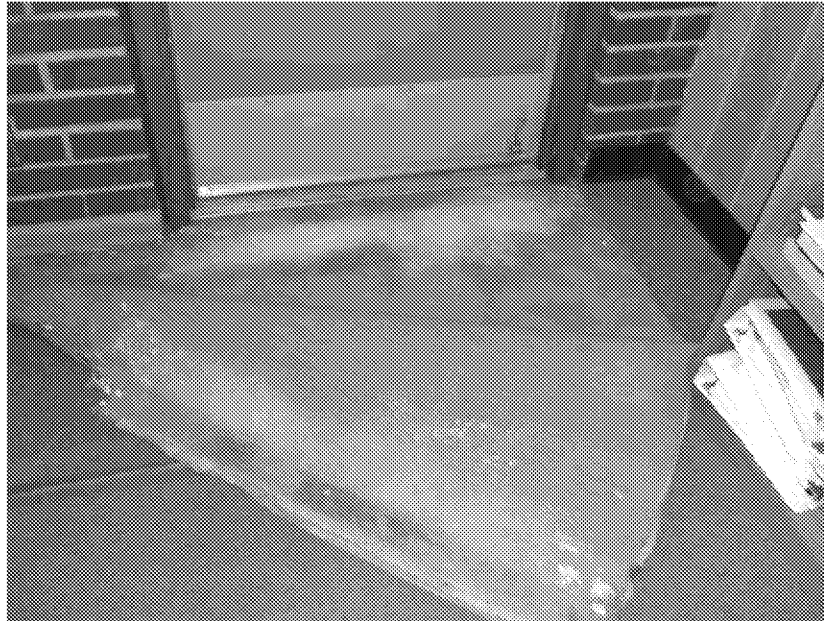
It is well-known that entrance thresholds become wetted by people entering the building from outside or from water passing beneath the door threshold. In this case it doesn't appear likely that water passed below the doorway so the most likely reason the carpets become wet at the thresholds is because wet shoes tracked in moisture from outdoors.

PHOTO #9: When pulled back, the carpet by the door shows that the mastic on has been well-cured and some mastic remains on both the carpet backing and the concrete slab. The darker discoloration near the edge of the carpet that abuts the exterior door threshold was slightly “crusty”.

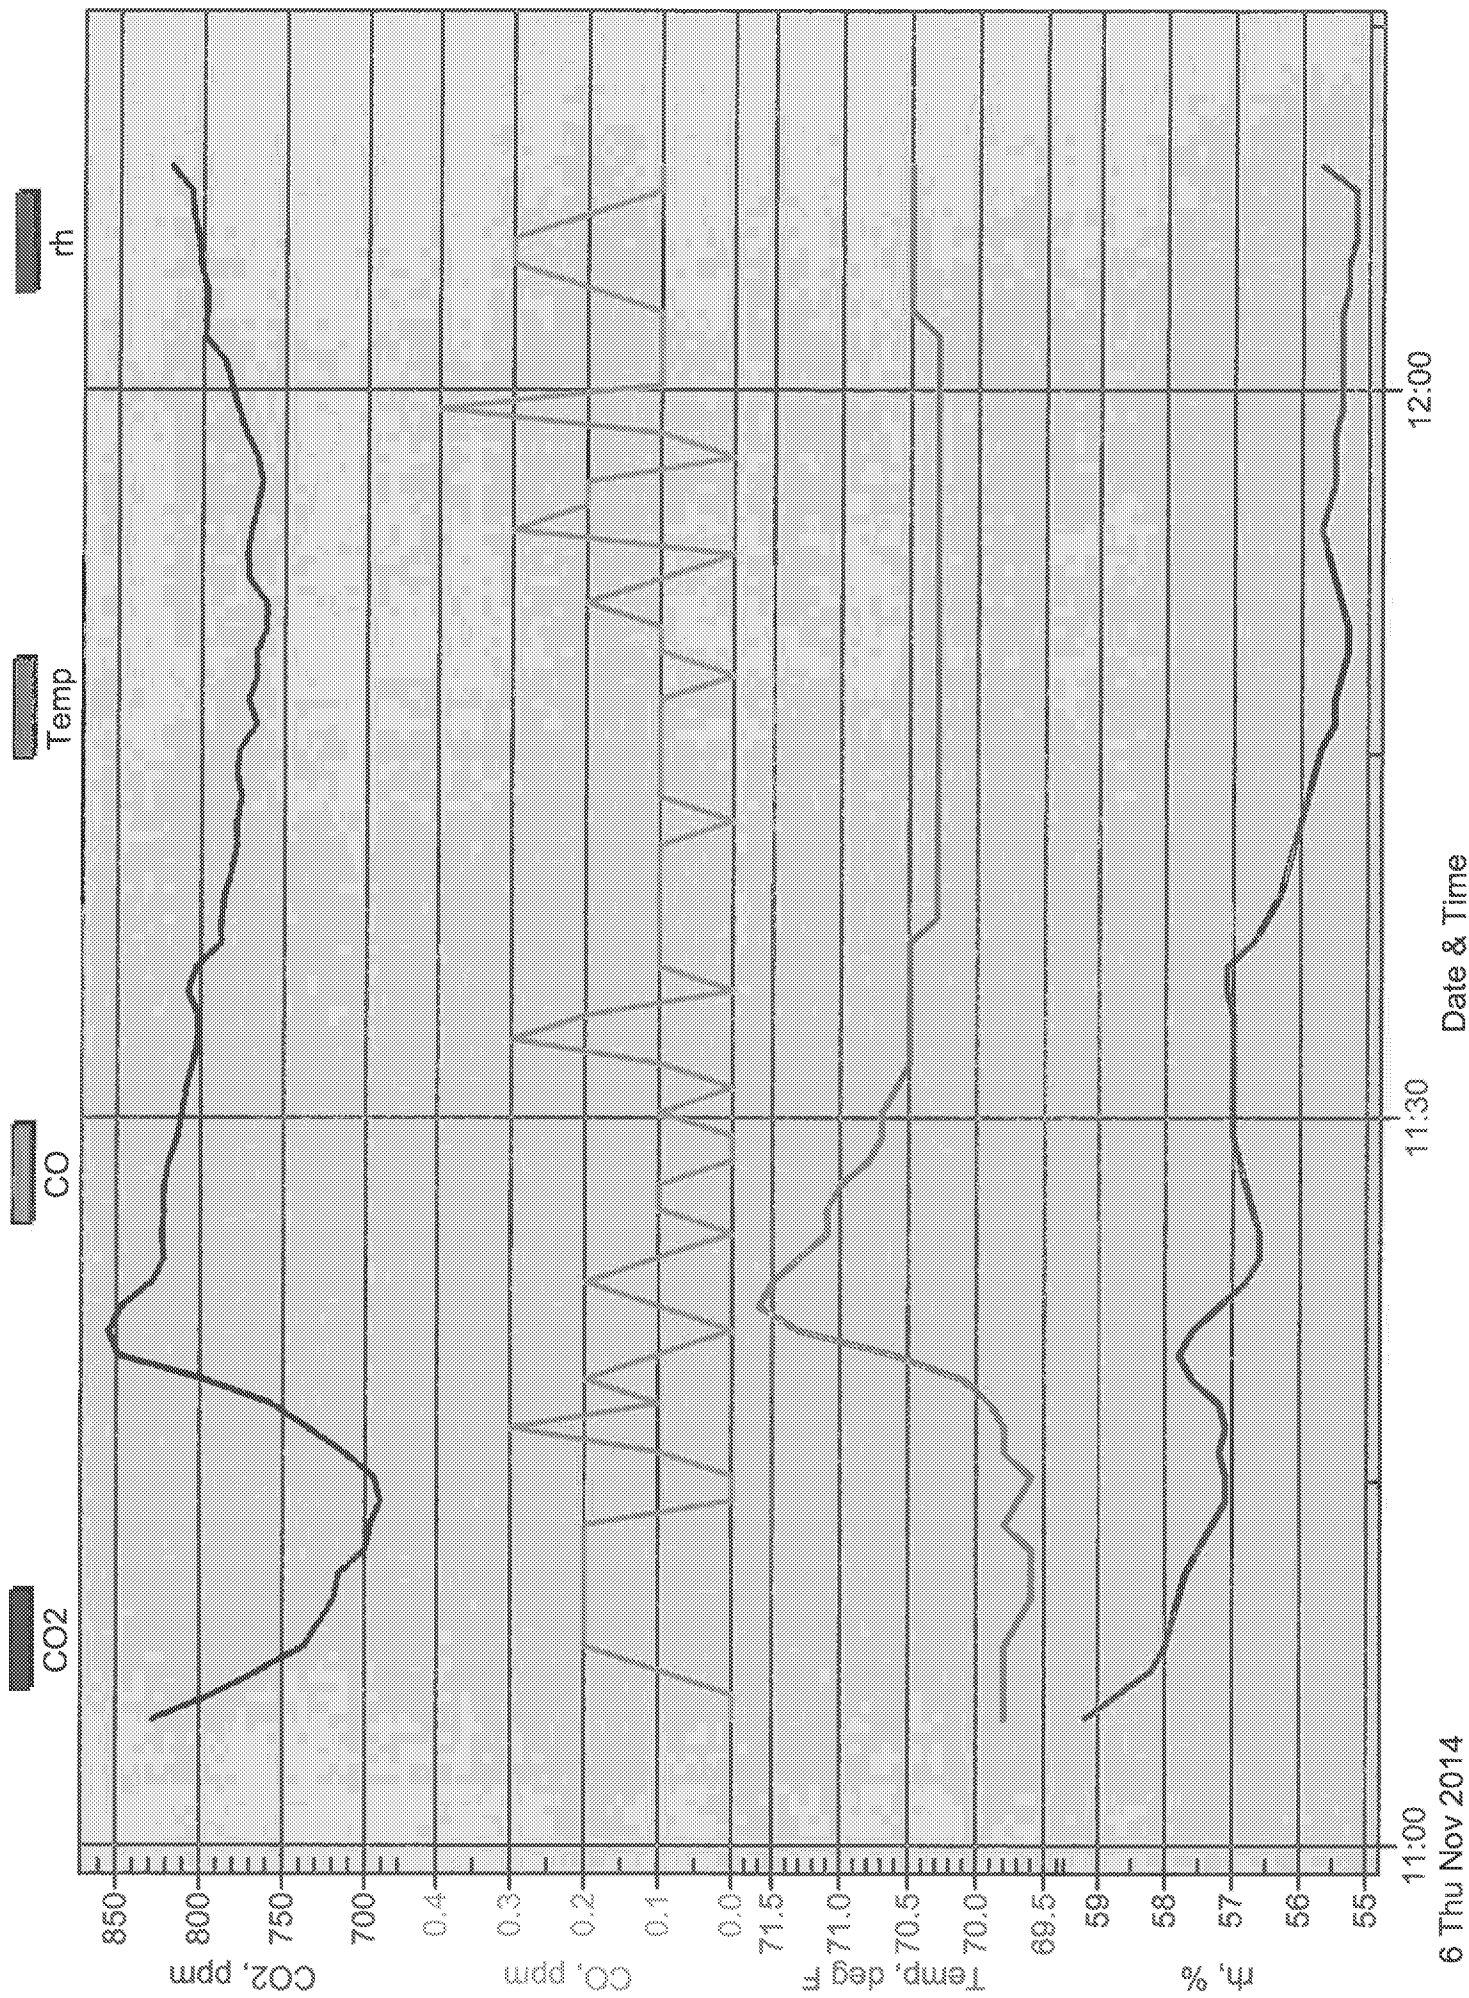
Room 11

Data-logging conducted in Classroom 11 while approximately twenty (20) students were in session indicates that the carbon dioxide concentration increased from approximately 700 ppm to a high of 855 ppm before it fell gradually to approximately 750 ppm. The average carbon dioxide concentration during the classroom session was 782 ppm.

The temperature rose from a before session temperature of approximately 69.5° F to a high of 71.6° F shortly after the class session began. The temperature then decreased to approximately 70° F and stayed there for the remainder of the class session. The average temperature during the class session was 70.3° F.

The relative humidity in the classroom started slightly above 59% and decreased throughout the class session to a relative humidity of approximately 55%. The average relative humidity during the class session was 56.5%.

**Sky Valley Education Center
Classroom 11
IAQ Parameters
November 6, 2014**
